FINAL TECHNICAL REPORT

**FRETTING CORROSION IN AIRFRAME RIVETED
AND PINNED CONNECTIONS**

(Grant No. F49620-93-1-0488)

George T. Hahn and Carol A. Rubin

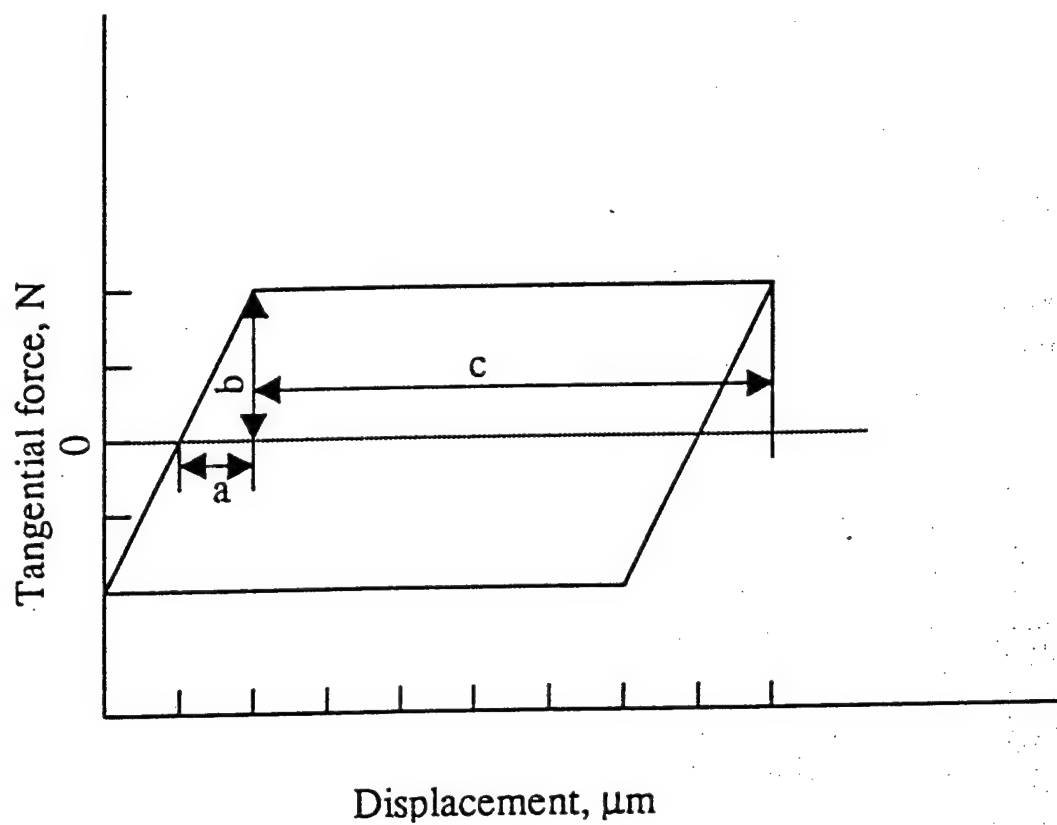
Figure 2 Schematic drawing of a typical tangential force-displacement (Ft-D) hysteresis loop. a/b defines the system compliance and c is the local slip amplitude.

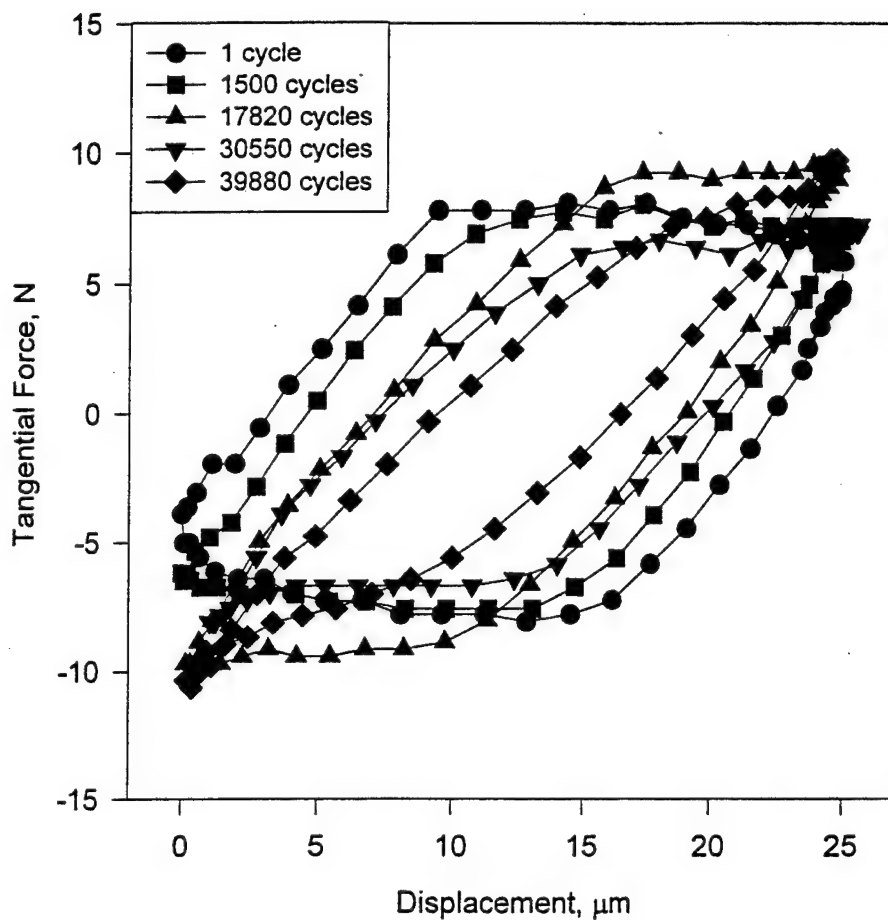
Figure 3(a) Evolution of friction logs with number of fretting cycles for 7075-T6 vs. 7075-T6 with $f = 1.0$ Hz under $p_0 = 1000$ MPa at a total displacement $\delta_t = 25$ μm in saline solution.

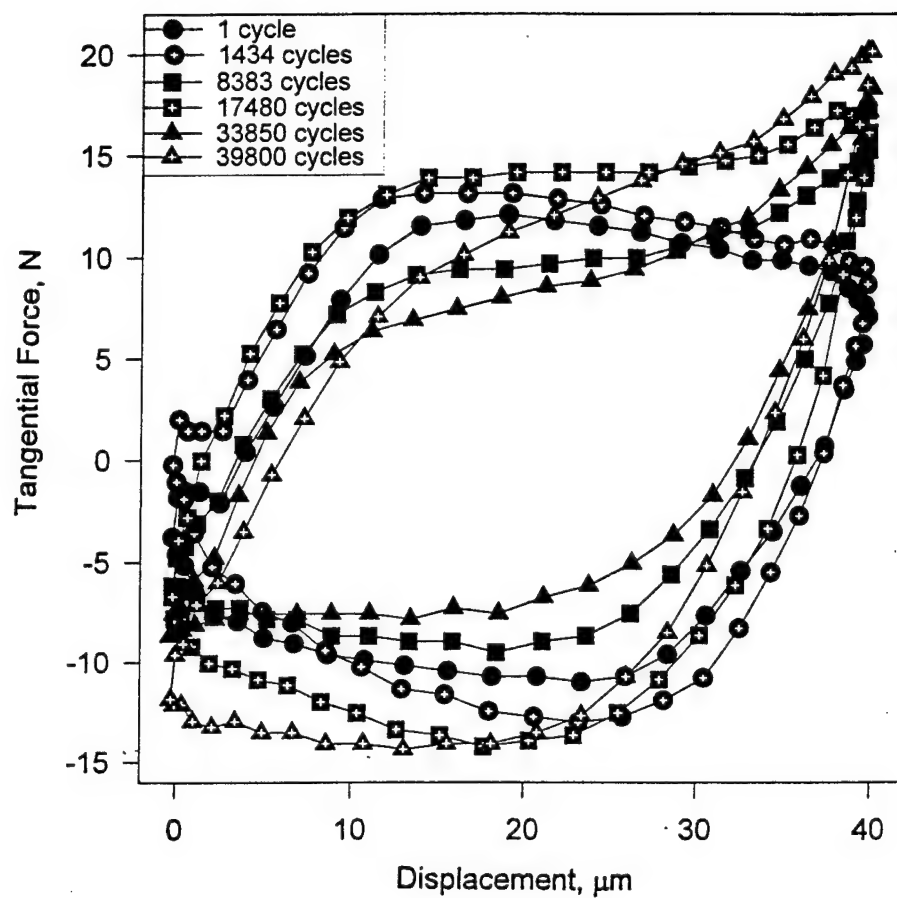
Figure 3(b) Evolution of friction logs with number of fretting cycles for 7075-T6 vs. 7075-T6 with $f = 1.0$ Hz under $p_0 = 1000$ MPa at a total displacement $\delta_t = 40$ μm in saline solution.

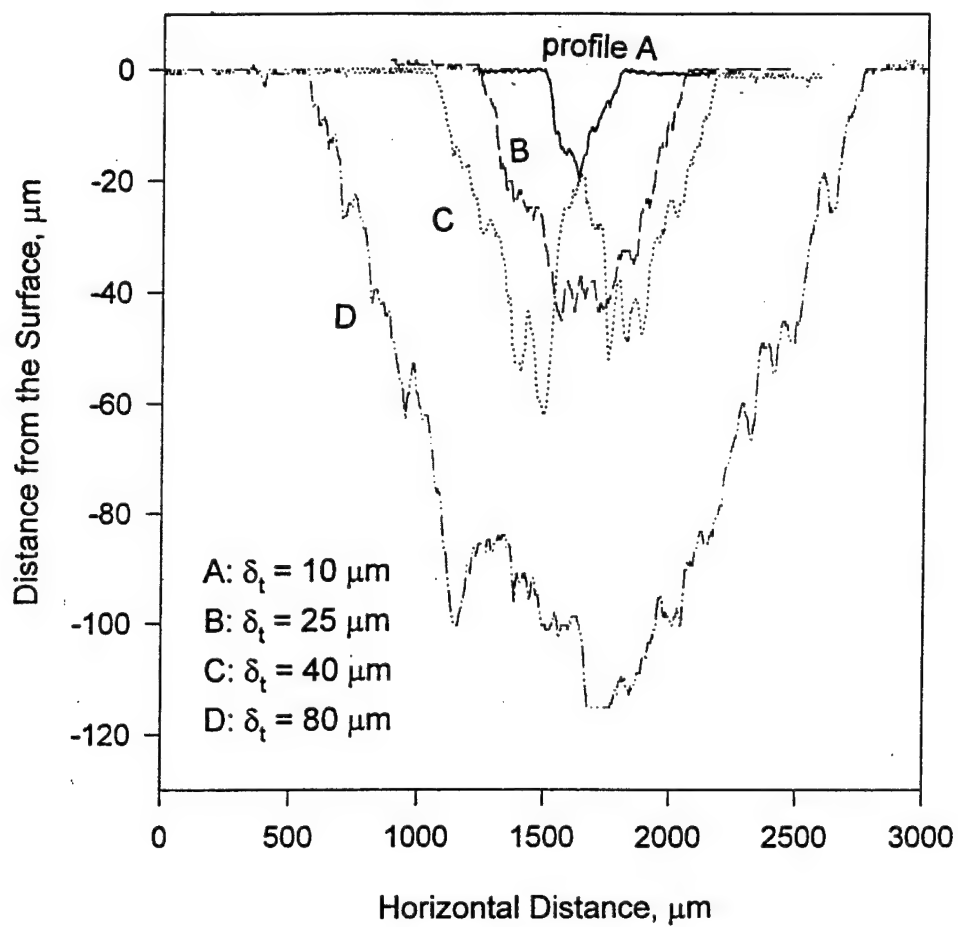
Figure 5(a) Profilometer measurements of the wear scars produced by $N = 4 \times 10^4$ fretting cycles for 7075-T6 samples against 7075-T6 in saline solution with $p_0 = 1000$ MPa, and total displacement $\delta_t = 10 \mu\text{m}$, $25 \mu\text{m}$, $40 \mu\text{m}$ and $80 \mu\text{m}$, respectively.

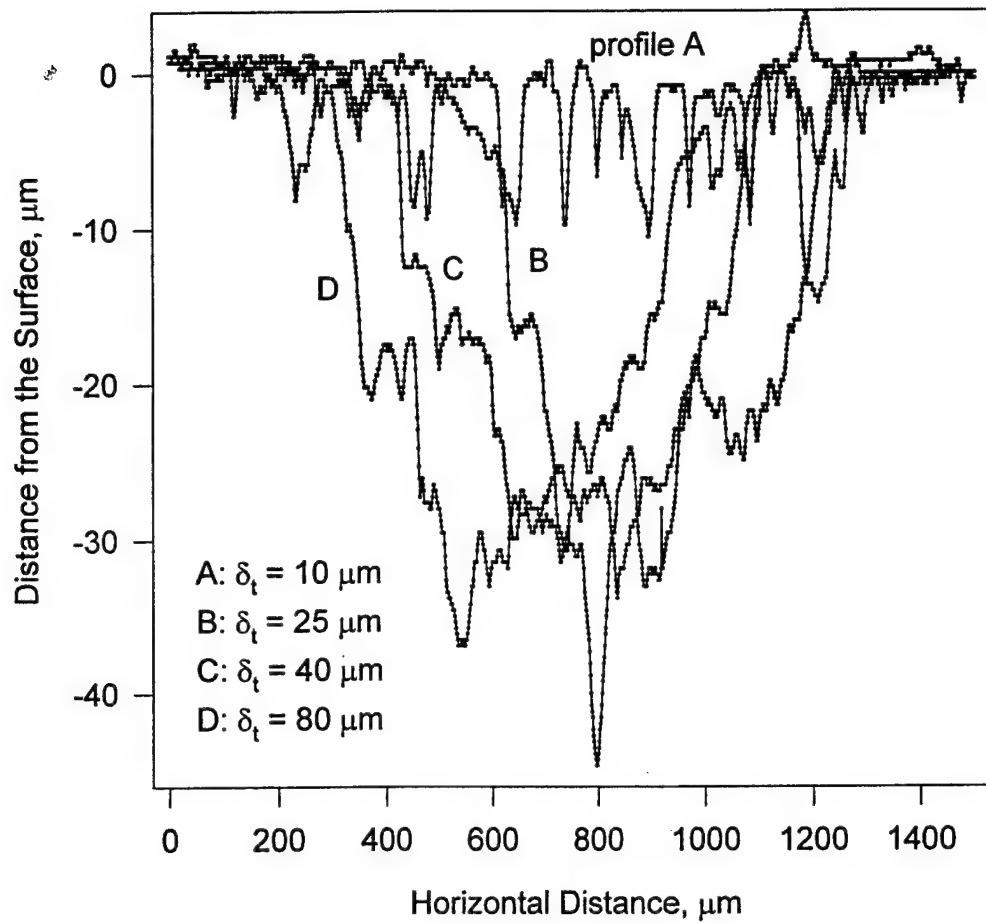
Figure 5(b) Profilometer measurements of the wear scars produced by $N = 4 \times 10^4$ fretting cycles for 7075-T6 samples against steel in saline solution with $p_0 = 1000 \text{ MPa}$, and total displacement $\delta_t = 10 \mu\text{m}$, $25 \mu\text{m}$, $40 \mu\text{m}$ and $80 \mu\text{m}$, respectively.

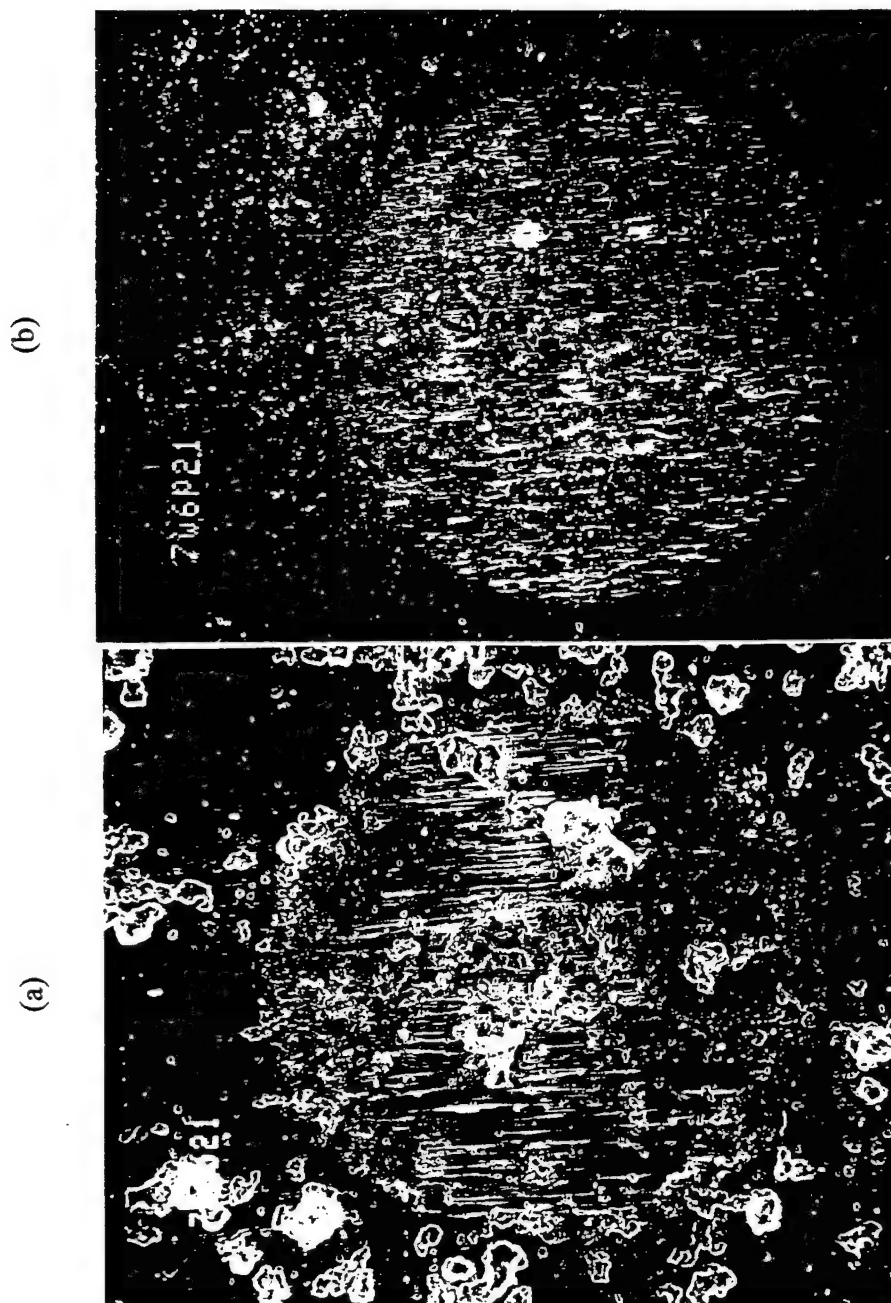
Figure 6 Micrographs of wear scars obtained after $N = 4 \times 10^4$ fretting cycles for $p_0 = 1000$ MPa, $\delta_t = 80$ μm and $f = 1.0$ Hz in saline solution for 7075-T6 against: (a) a 7075-T6 hemisphere, (b) a 52100 steel sphere.

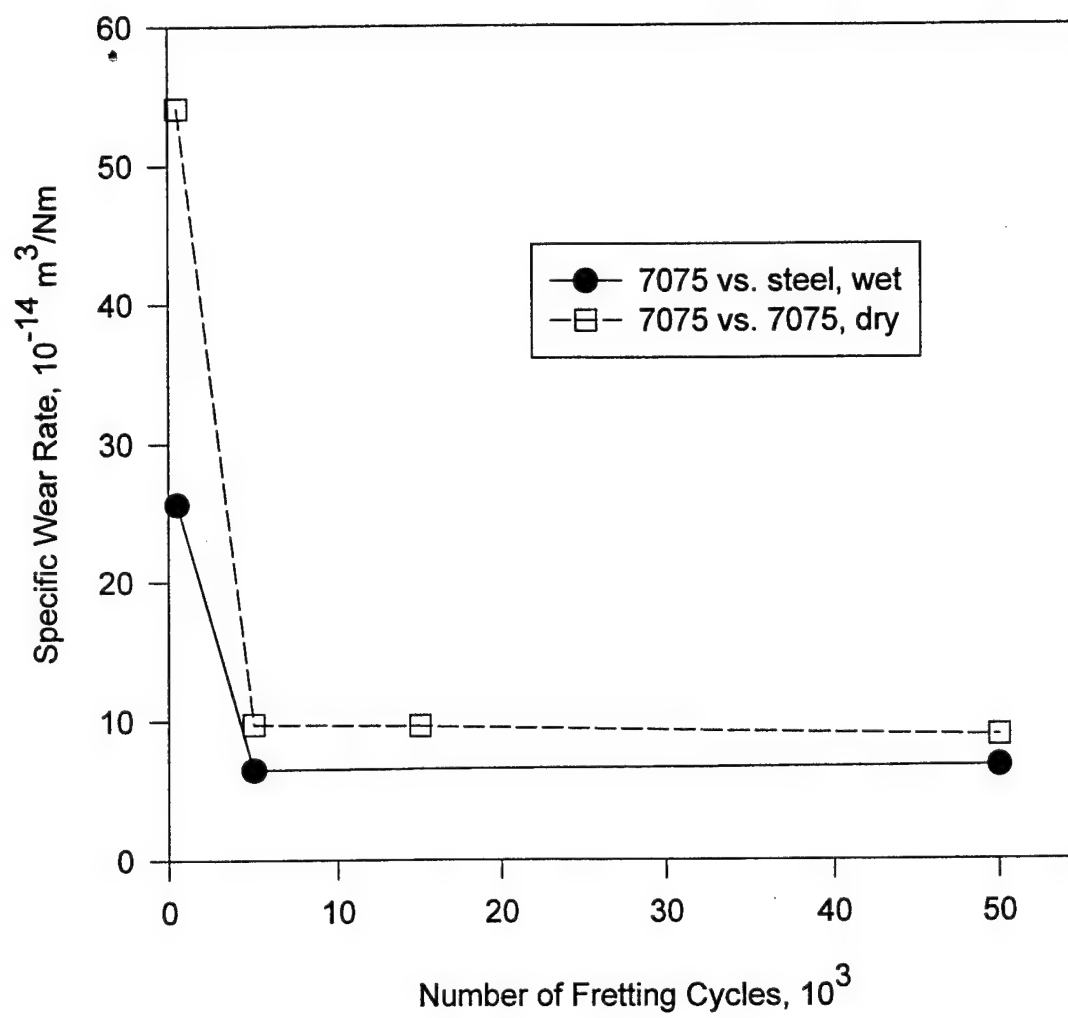
Figure 7 Variation of the specific wear rate, W_s , with the number of cycles for 7075-T6 against a 52100 sphere (●) in saline solution, and against 7075-T6 (□) in ambient air for $p_0 = 1000 \text{ Mpa}$, $\delta_t = 40 \text{ }\mu\text{m}$ and $f = 1.0 \text{ Hz}$.

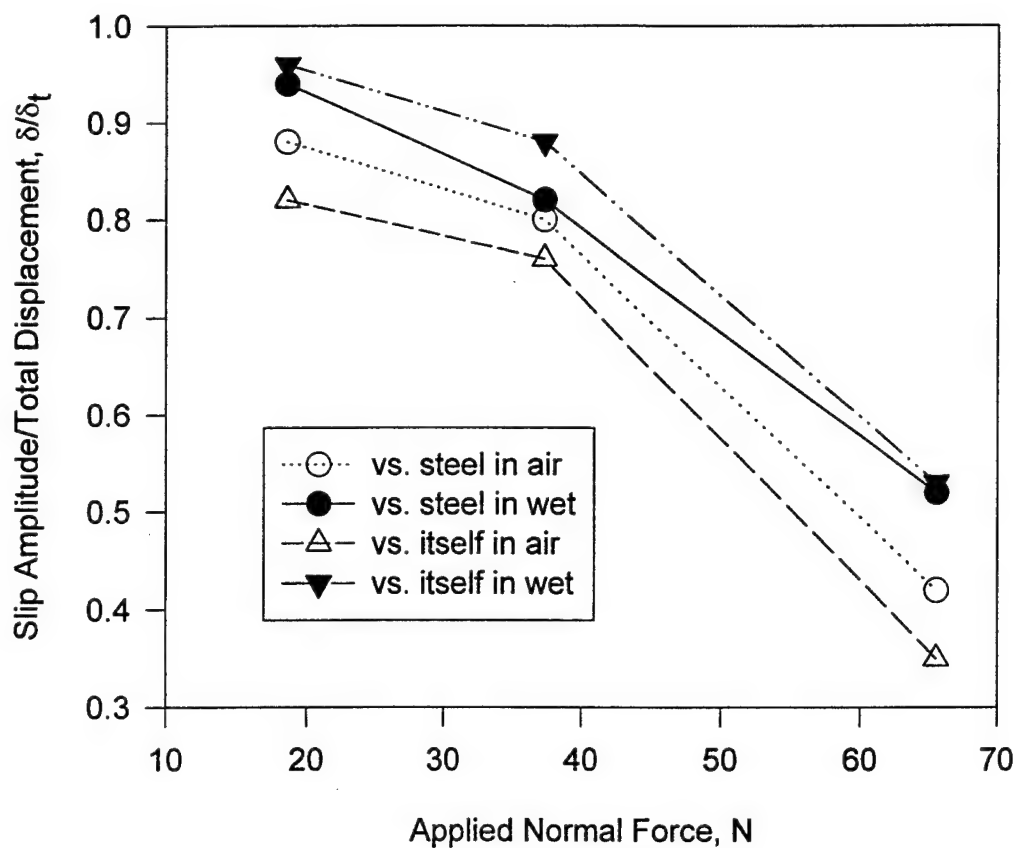
Figure 10 Plot of fretting ratio, slip amplitude/total displacement (δ/δ_t), as a function of the normal force for 7075-T6 after $N = 4 \times 10^4$ fretting cycles against 7075-T6 in ambient air (▼) and saline solution (△), against steel in air (○) and in saline solution (●). Higher normal force leads to smaller local slip amplitude.

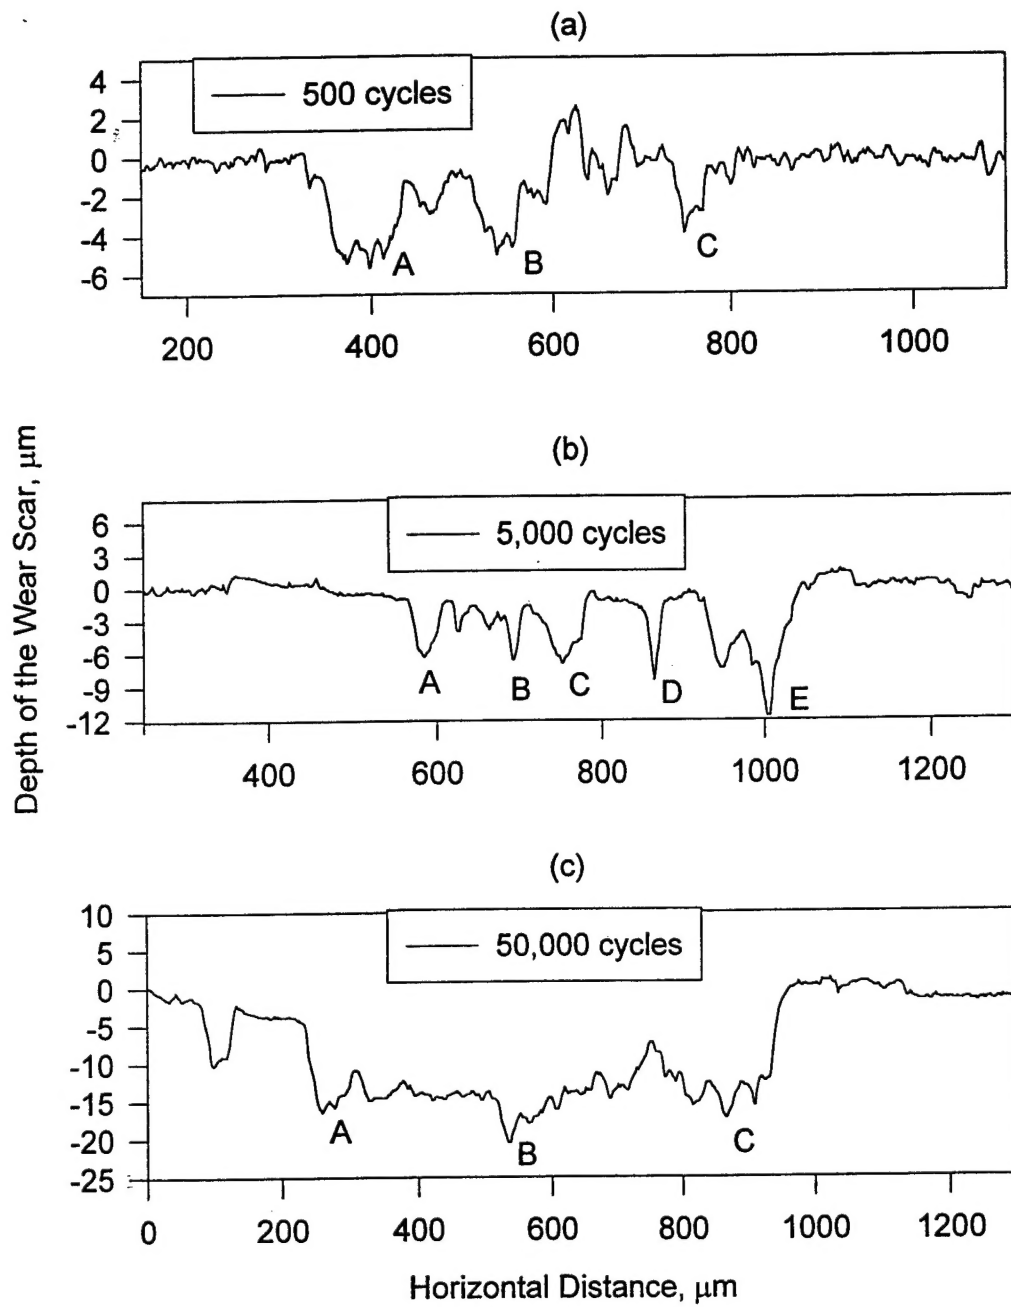
Figure 12 Profilometer traces of cleaned 7075-T6 sample against a steel ball in saline solution after: (a) $N = 500$, (b) $N = 5,000$, (c) $N = 50,000$ fretting cycles, for $p_0 = 407$ MPa and $\delta_t = 40$ μm .

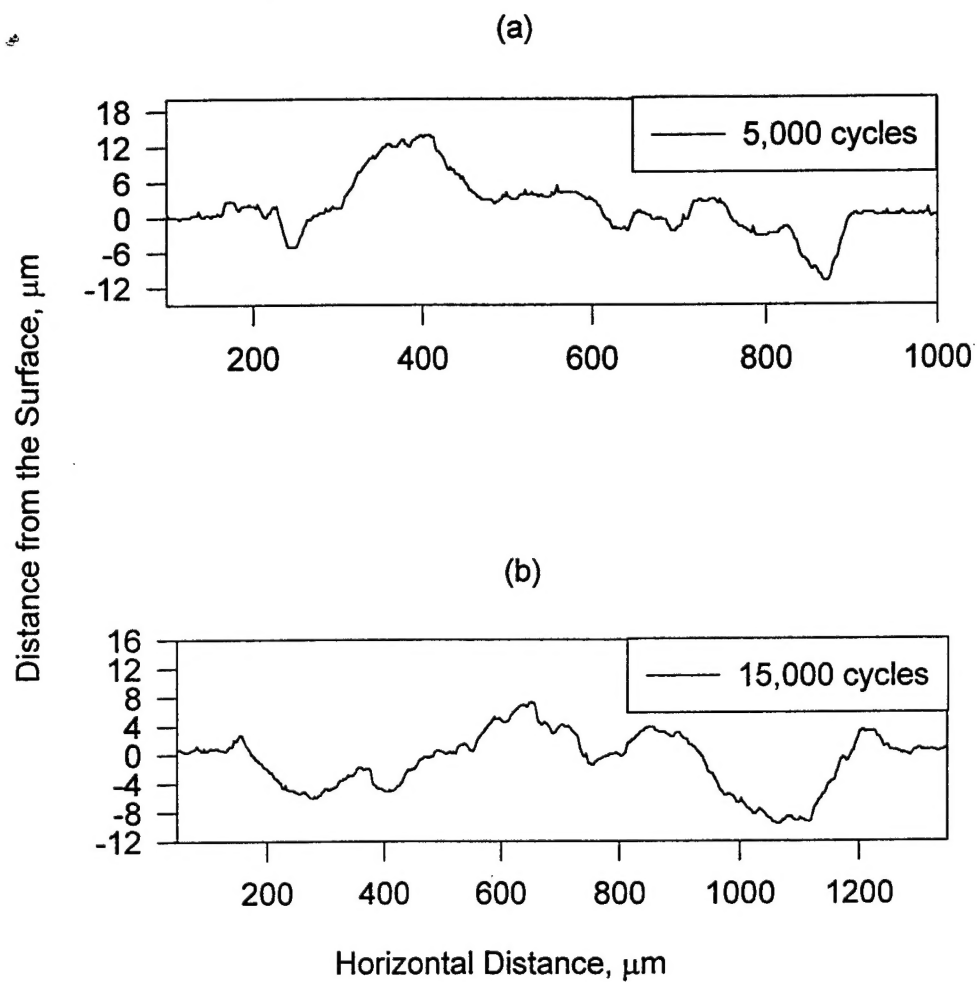
Figure 13 Profilometer traces of cleaned 7075-T6 sample against a steel ball in air after: (a) $N = 5,000$, (b) $N = 15,000$ fretting cycles for $p_0 = 407 \text{ MPa}$ and $\delta_t = 80 \mu\text{m}$.
